# Roof Coating Forensics

by: Fred Wolfe  
GE Silicones

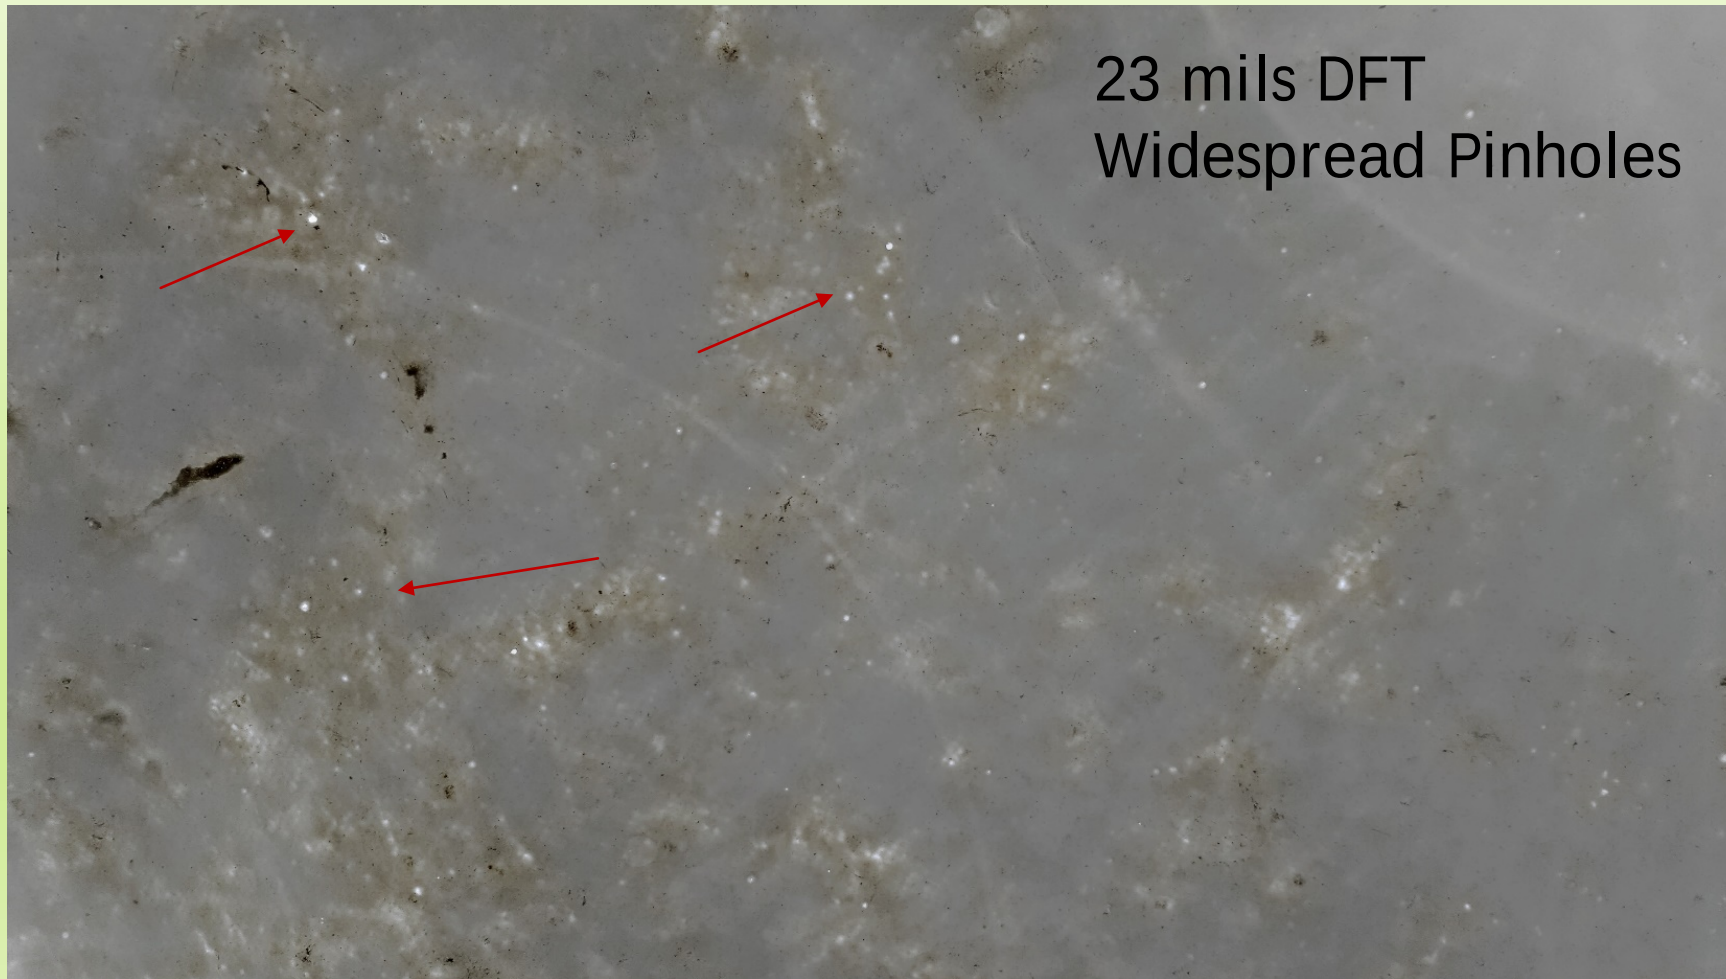
# Silicone Film on Light Table

- ▶ Customer reported peeling coating on a concrete roof
- ▶ A sample of the coating was obtained
- ▶ A detailed examination of the coating
- ▶ A report was generated and sent to the customer with instructions

- ▶ Roof was coated while concrete was saturated.
- ▶ Customer did not perform a moisture scan before coating.
- ▶ Solution was to grind off any remaining coating.
- ▶ Add a moisture lock primer to the surface.
- ▶ Re-coat the roof according to manufacturer specification.

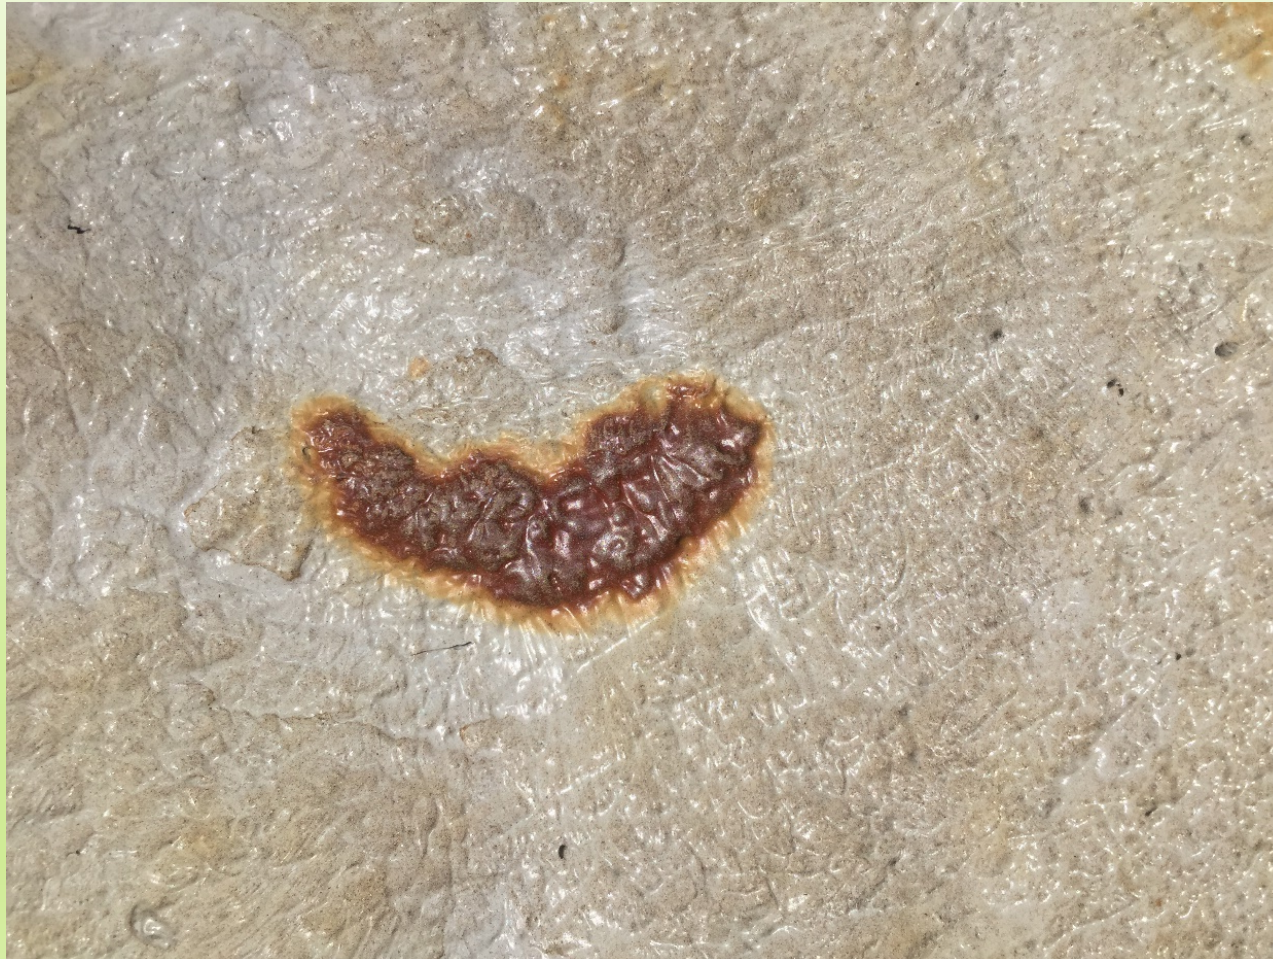
# Site Visit

- ▶ Customer very upset by “burn” marks.
- ▶ Roof coating was about a year old.
- ▶ Roof site visit was made.

- ▶ I was able to replicate the burn marks in the lab with a torch.
- ▶ We checked the surroundings as to what may have caused burns.
- ▶ Discovered that the 4<sup>th</sup> of July fireworks are shot off very close to this building from a barge on the water.
- ▶ Searched the internet, and found someone who had video of the fireworks that year.
- ▶ The lighted logo of the building was visible under the bursts of the fireworks.
- ▶ Told customer to have a roofing contractor cut out and repair the coating, and to speak with the municipality about the fireworks.

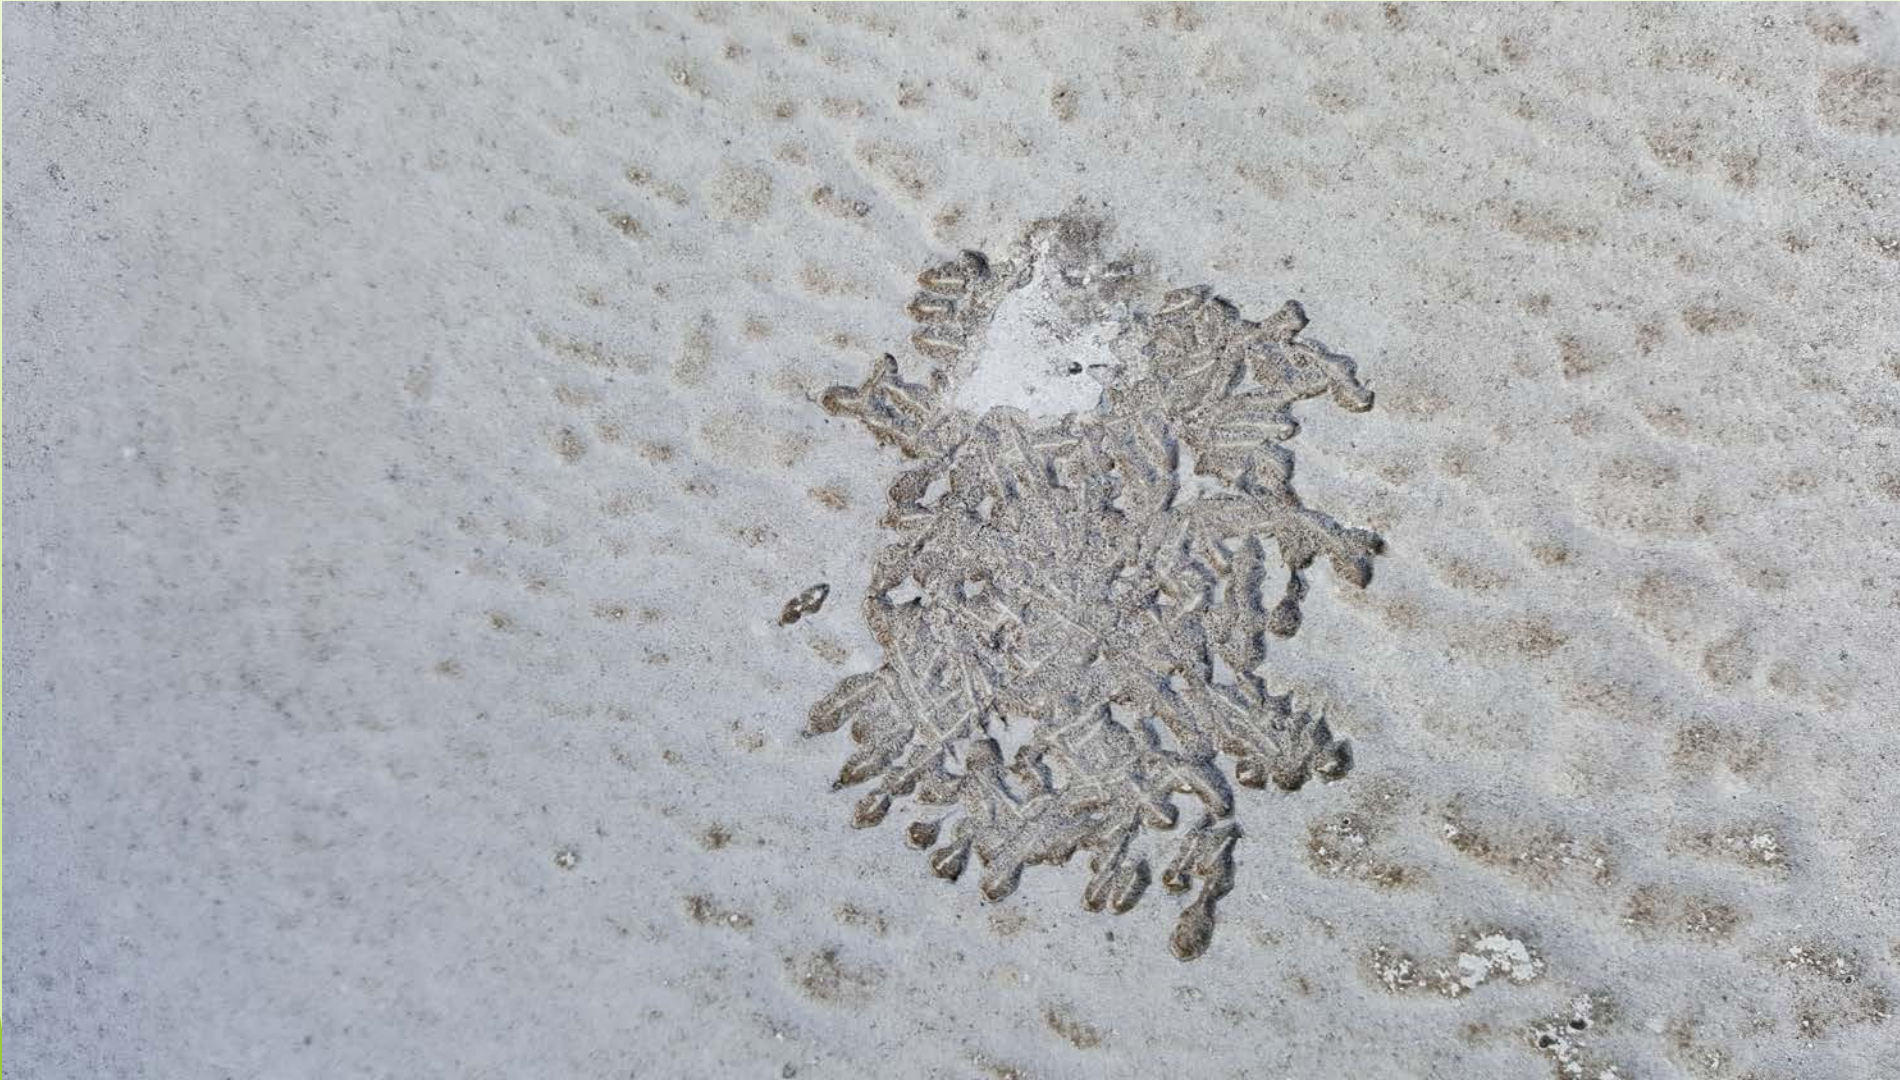
There were scratches in the middle of these “gouges” that went all the way down to the TPO membrane.

- ▶ We knew this was a wildlife problem, but weren't sure what kind.
- ▶ There was over grown vegetation along the back of the building, and overgrown oak trees.
- ▶ A wildlife camera was set up to capture footage.
- ▶ We found that chipmunks were to blame.
- ▶ In fact, an inspection of the vegetation showed lots of chipmunks, and damage to drain pipes, along with bits of silicone coating on the ground.
- ▶ The customer was told to remove the vegetation and call a pest control company.
- ▶ The roofing contractor pressure washed the roof and re-coated it.

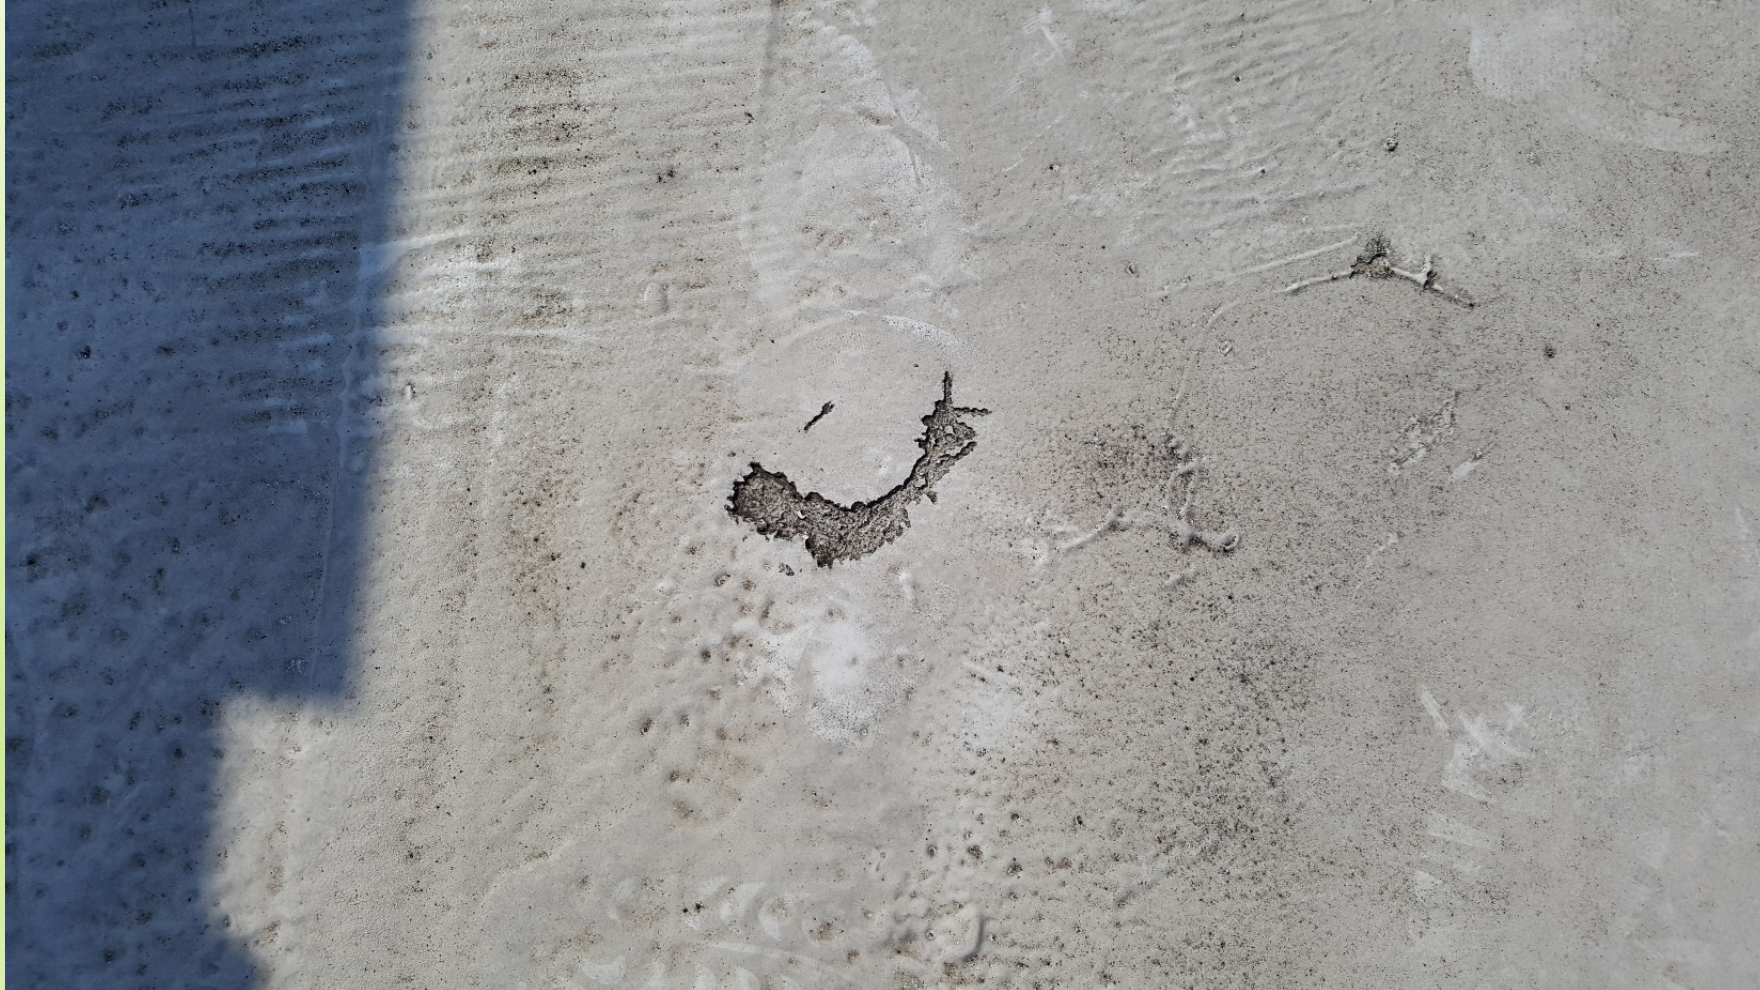
These marks were examined with a loupe, and determined to be “scoop” shaped.

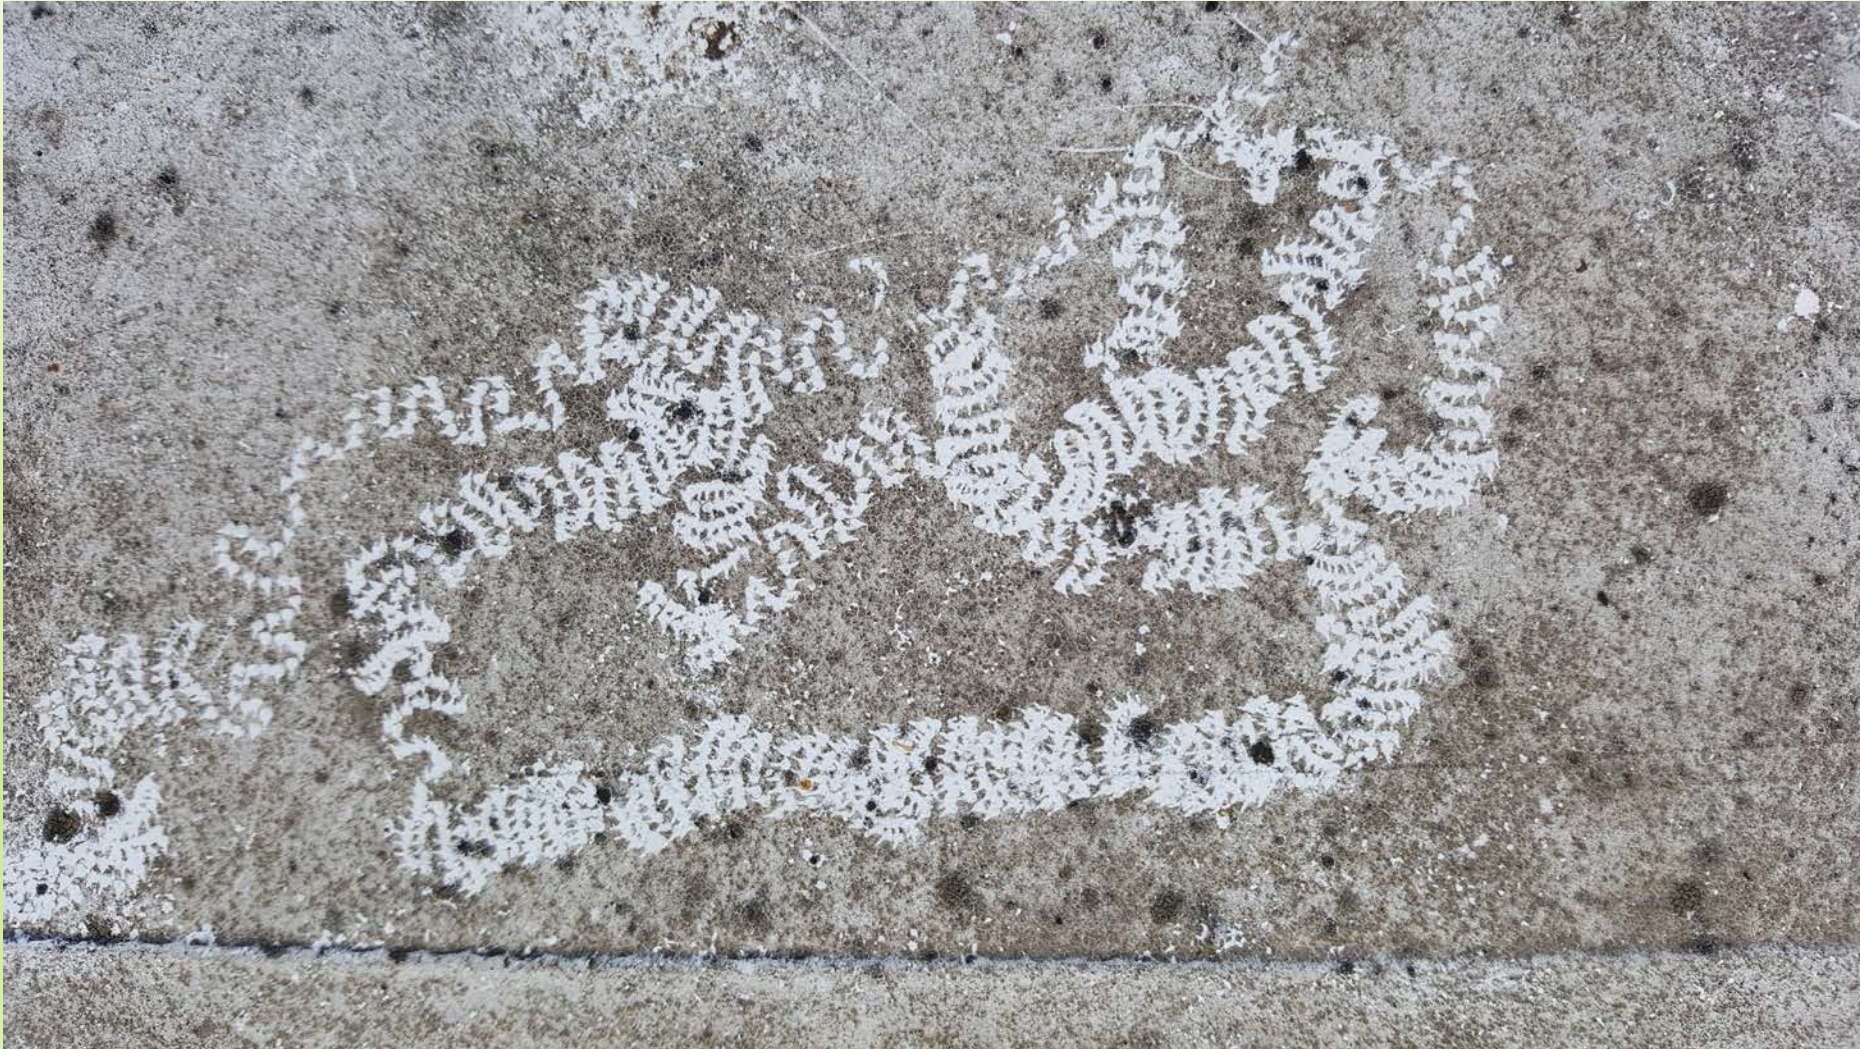
Snail trail

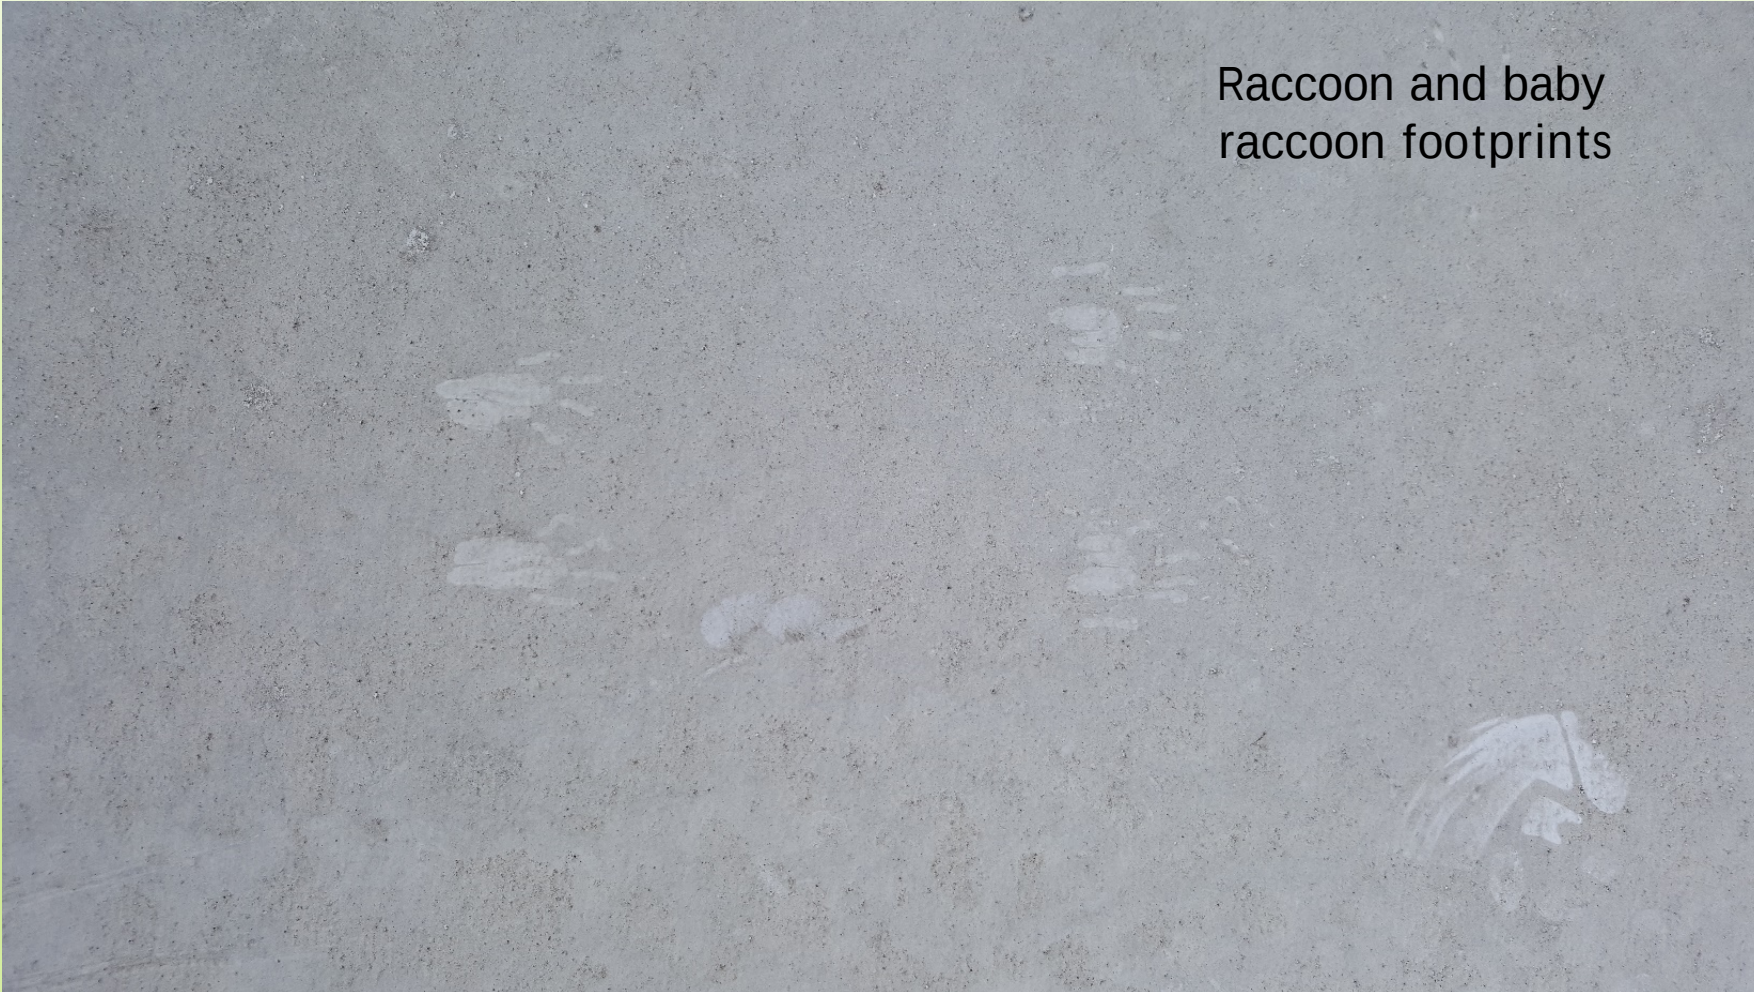
Raccoon and baby  
raccoon footprints

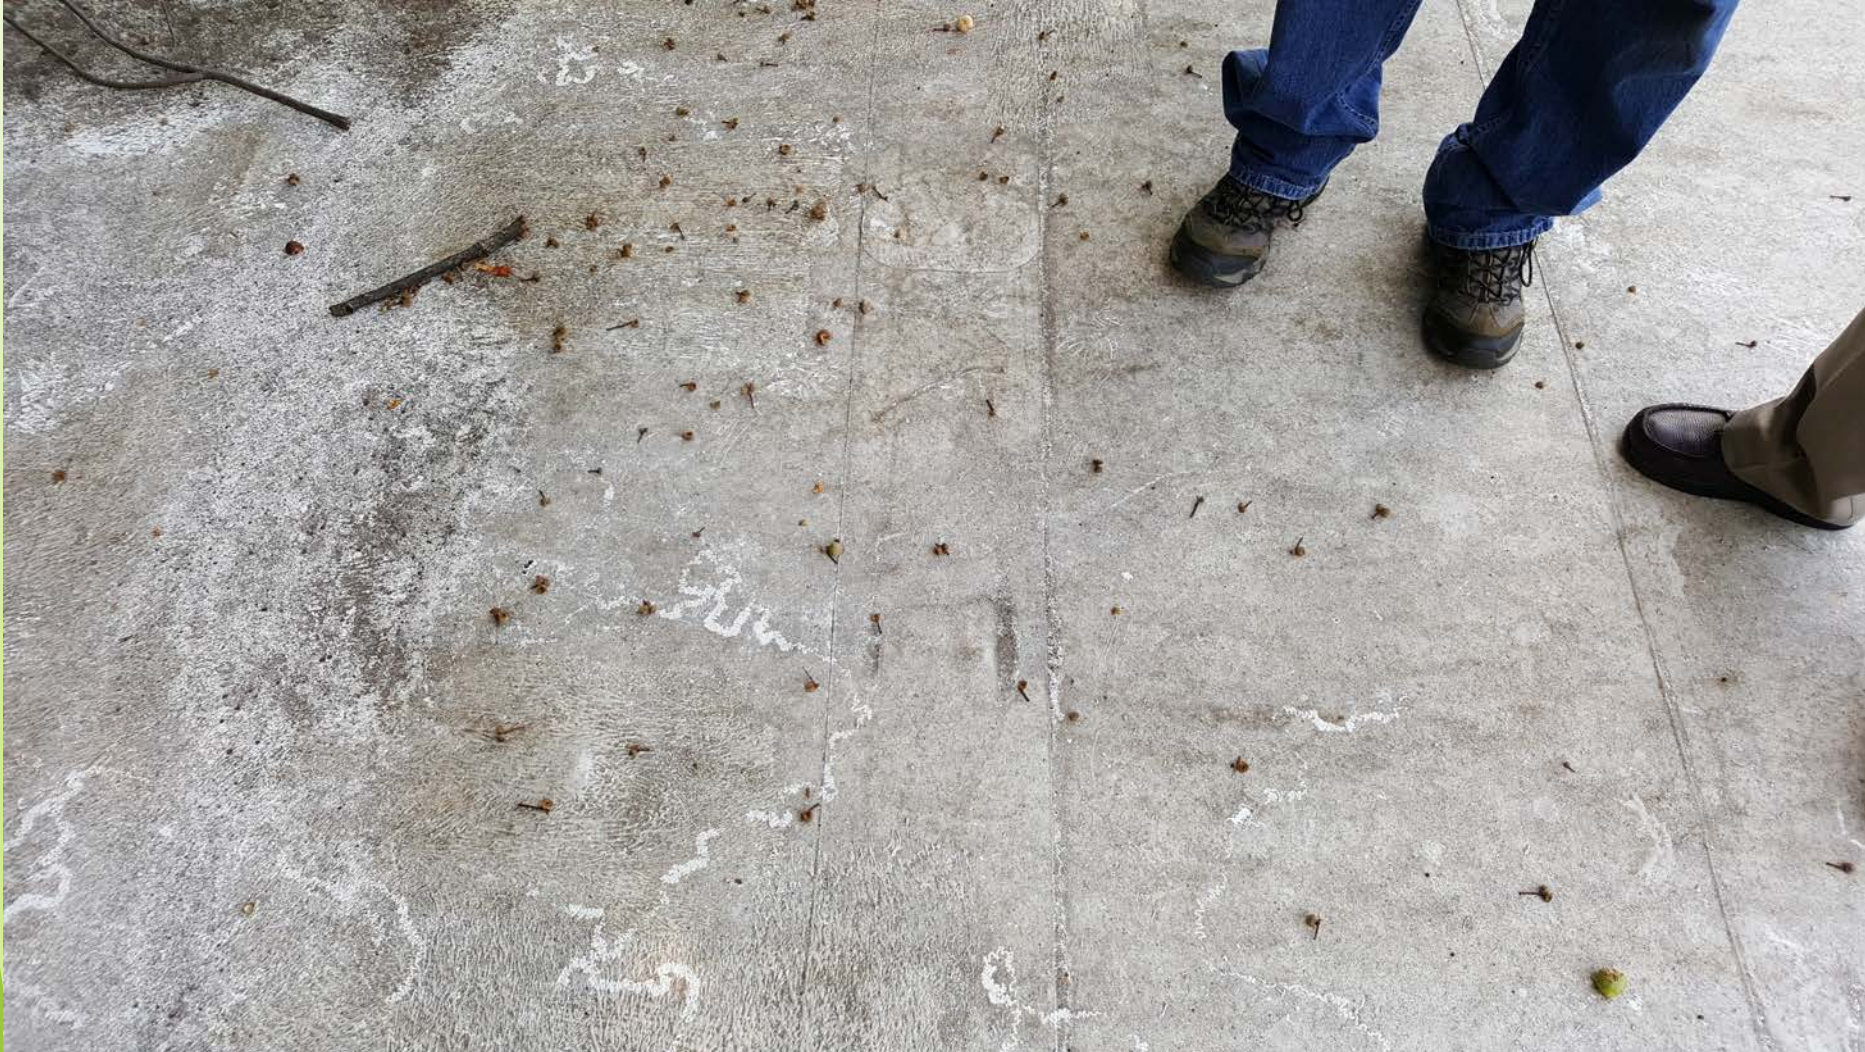
Acorn Stems

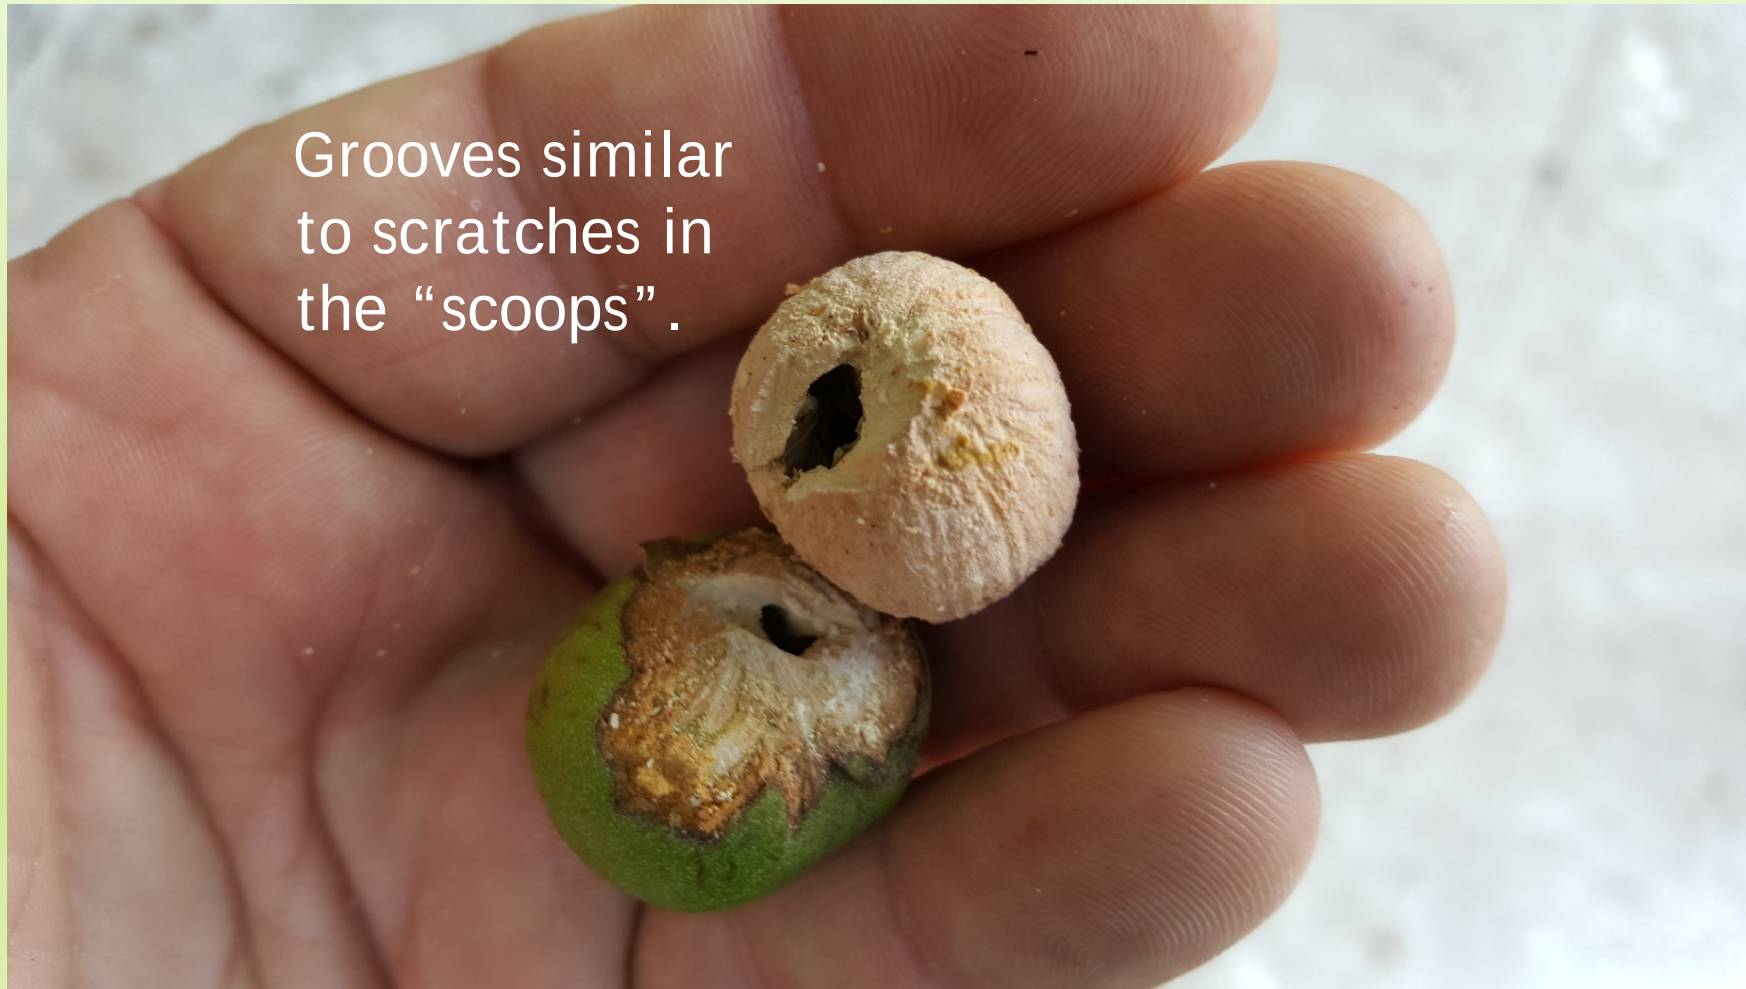
Gnawed acorns

Grooves similar  
to scratches in  
the “scoops”.
