Case study - S. Londonderry Elementary School (2004)

By way of introduction to this method, it was developed for moisture/mold remediation in an existing brick cavity-wall project where the back-up wall sheathing had become wet due to various airborne moisture transport mechanisms. Since that project, it has been used in similar retrofit situations that had flashing and drainage plane material failures.

Molly Ockett Middle School

Allen Memorial Museum – The Venturi Gallery

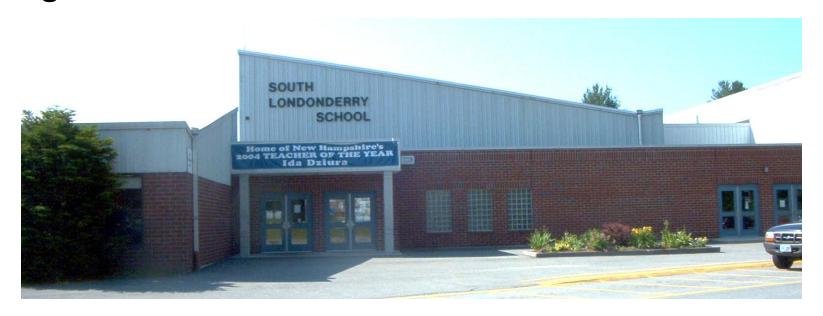
South Londonderry Elementary

Major remediation project – mold inside the brick cavity wall

Initial cavity wall inspection area. Problems noted include blocked weep holes, compromised capillary breaks, failing wall flashings, and no drainage plane to protect the sheathing.

The original problem: Through-wall air handler units were open to the brick cavity. Mold found in the cavity on the paper-faced drywall sheathing was determined to be the source of mold in the classrooms.

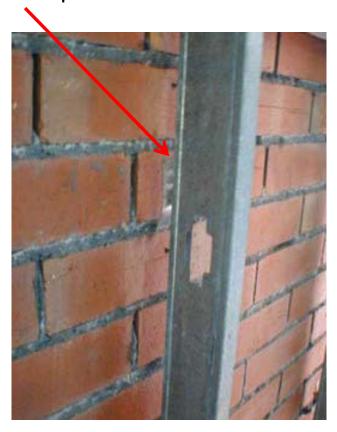
Brick and metal studs after removing the wet sheathing and mold. Brick ties were preserved where possible.

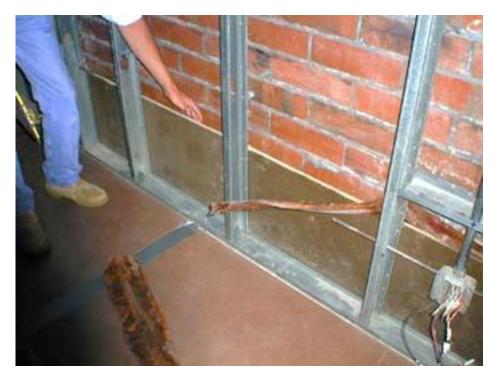
The existing conditions

Copper through-wall flashing was found mostly intact at the base of the wall

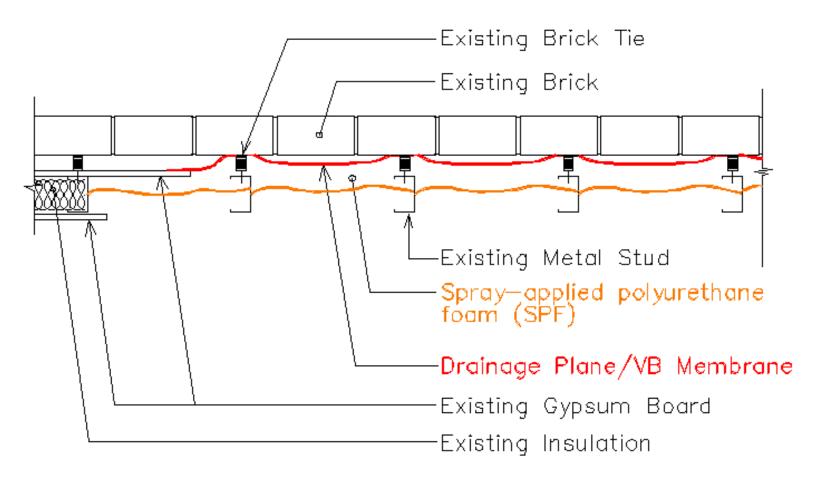
Horizontal section showing the existing brick and framing, the drainage plane location, and the profile of the SPF between the studs

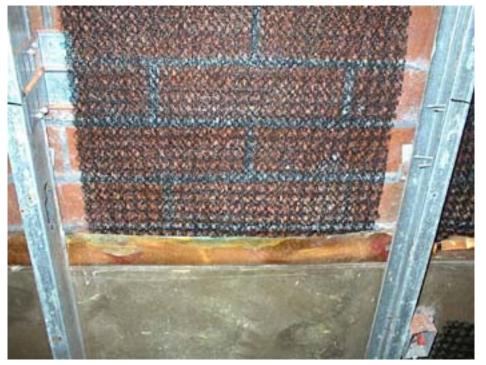
Install the spacer material against the brick, if used.

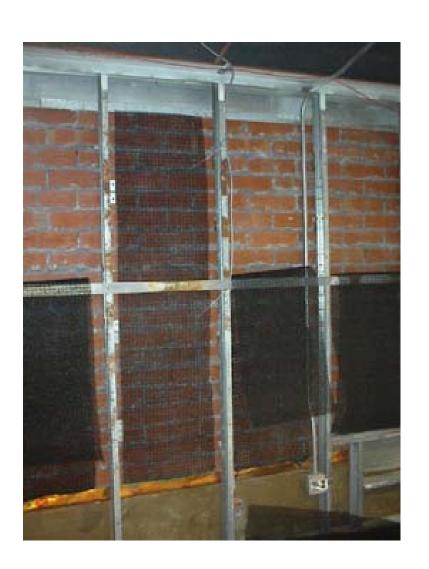
Install the spacer material to the bottom and on the outside of the flashing.

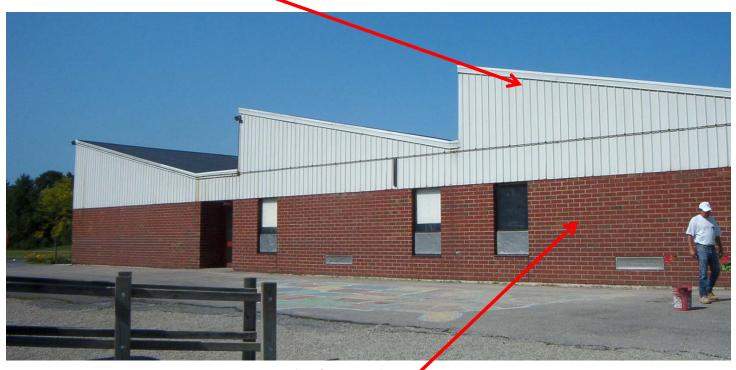
Insulated metal panels

Existing metal wall panels and wall base flashing above the brick

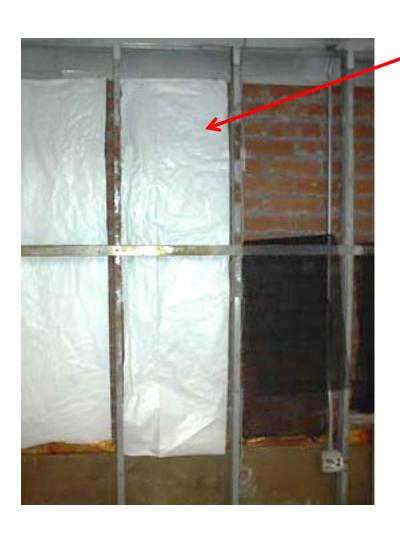
Drainage plane installed on the outside of the through-wall flashing

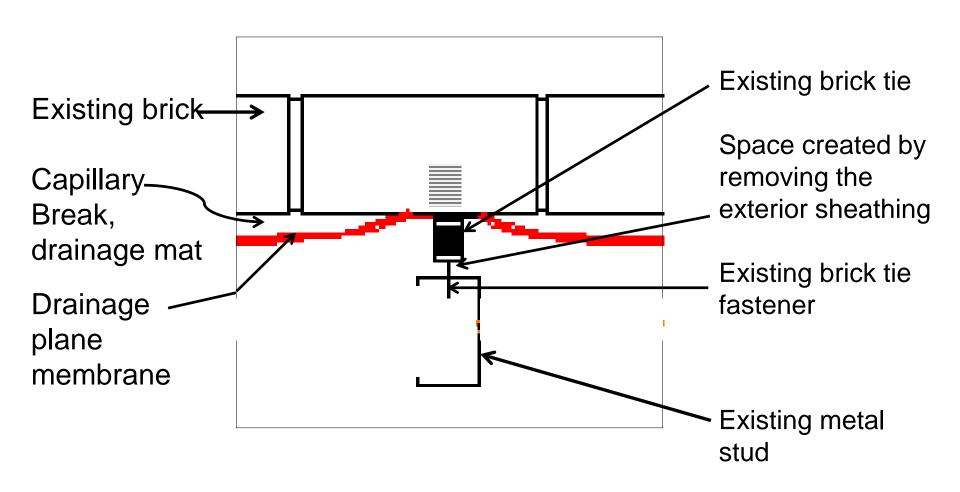
Install the drainage plane membrane starting at the top of the wall, even in multistory structures.

Lap the sections of membrane (if not one piece) to shingle them to shed water from the outside. Use strips of tape to position the membrane if required.

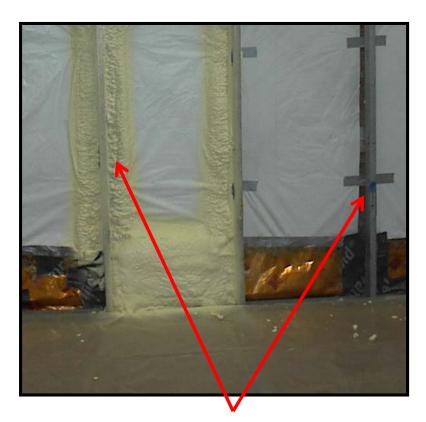
Install the SPF in vertical lines behind the studs to seal around the brick ties and where the drainage plane membranes meet.

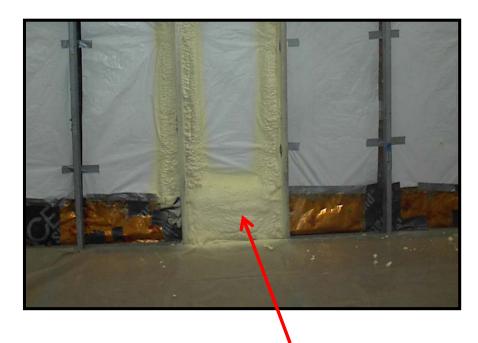
Flash coat the membrane to the through-wall-flashing before building up the insulation thickness

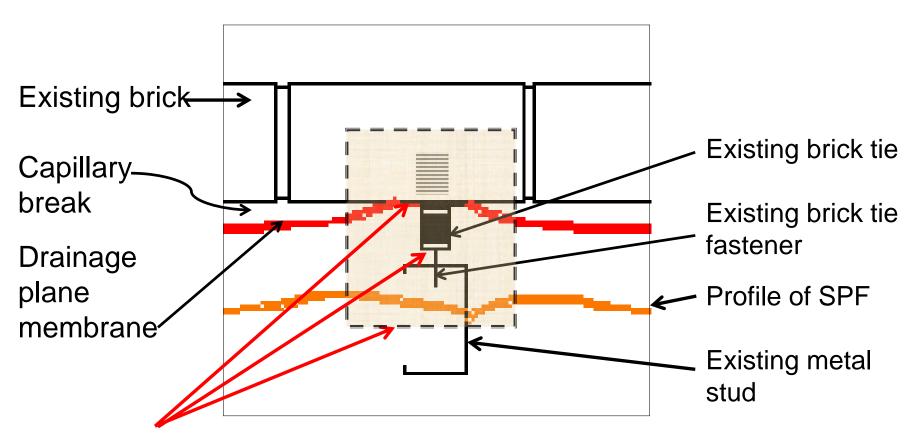
Filling this area first assures a seal around the brick tie and in the space originally occupied by the sheathing around the fastener.

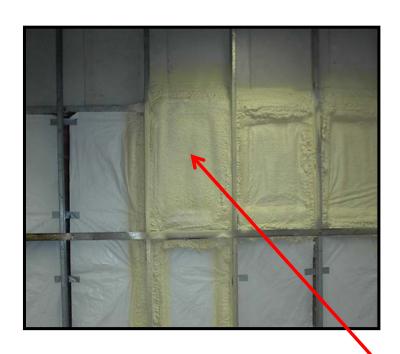
Fill in the wall bays after the picture frame areas have set up. Install lift thicknesses as recommended by the manufacturer.

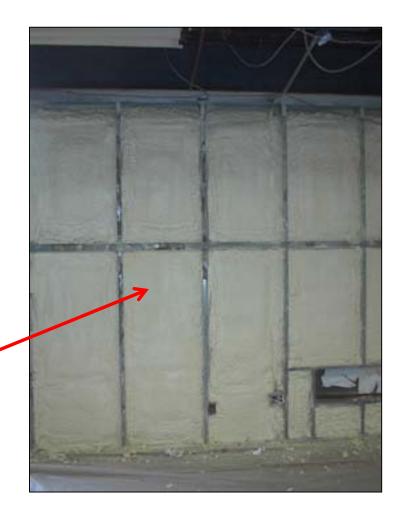
SPF with a 15- minute thermal barrier was used to seal a major air leakage site at the wall panel-to-roof deck transition.

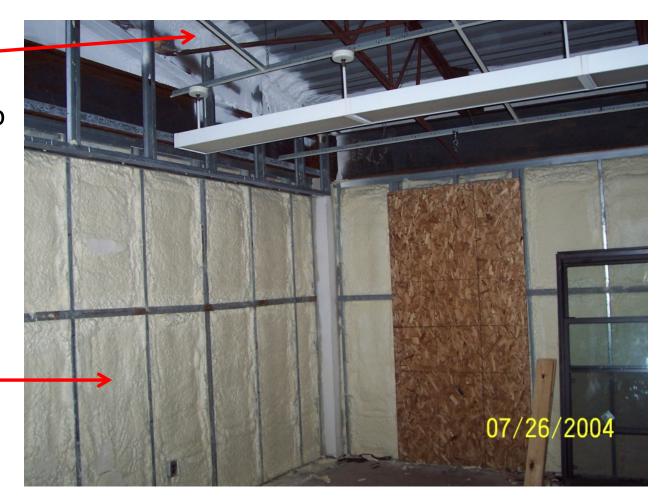
Ready for water test. Install the drywall finishes if there are no leaks.

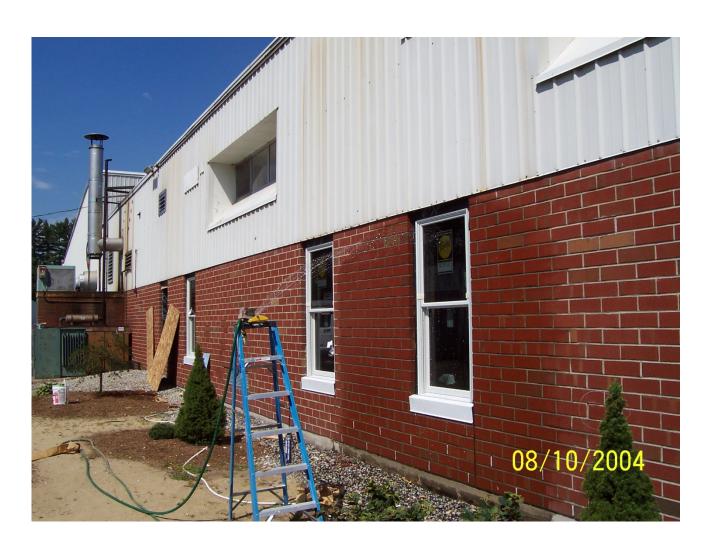
Verification: Engineer's water test to verify rain screen drainage

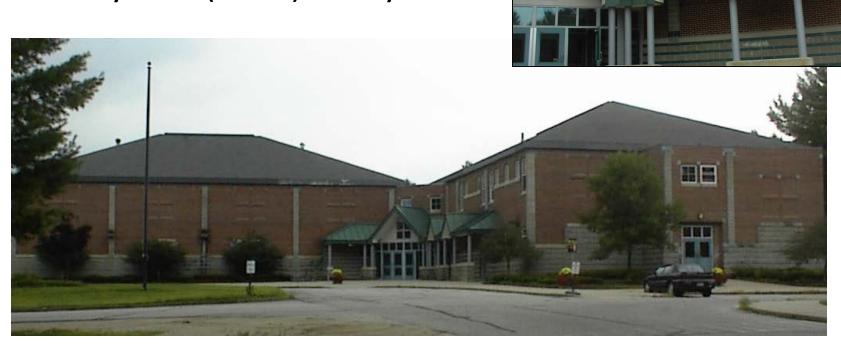
Major remediation project – water and mold found inside the brick and concrete masonry unit (CMU) cavity wall.

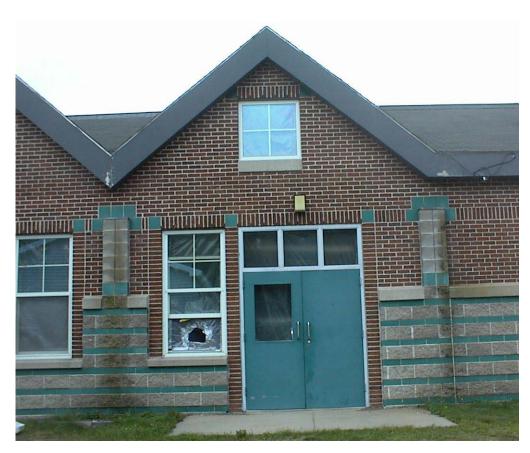
Molly Ockett Middle School

Problems noted during the initial cavity wall inspection include weep holes blocked, compromised capillary breaks, and missing or failing wall flashings.

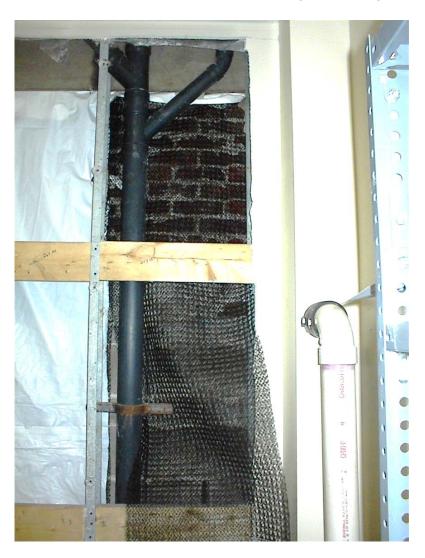
Goal: Maintain a capillary break behind the drainage plane

The Molly Ockett project used Cedar Breather to assure a capillary break space behind the drainage plane. Start at the top.

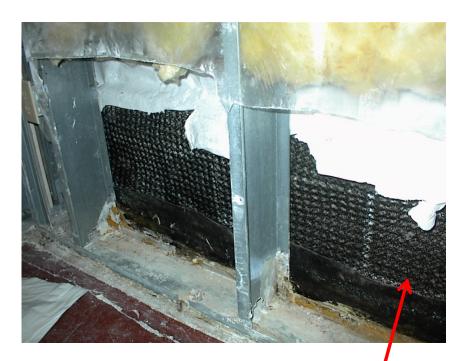
Install the spacer material on the outside of the through-wall flashing.

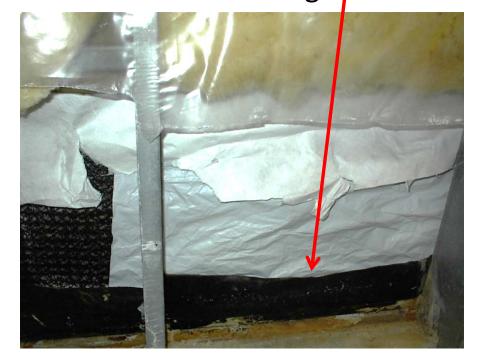
Install the drainage membrane on the outside of the throughwall flashing.

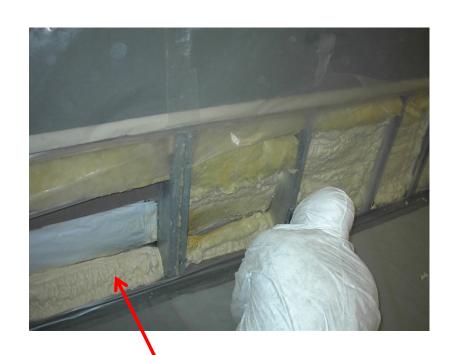
Flash coat the membrane to the through-wall-flashing before building up the insulation thickness

Install the SPF in vertical lines behind the studs to seal around the brick ties and where the drainage plane membranes meet.

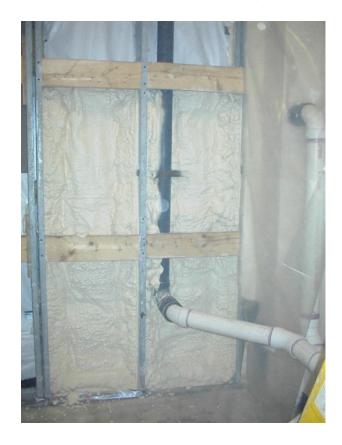
Fill in the wall bays after the picture frame areas have set up. Use lift thickness as recommended by the manufacturer.

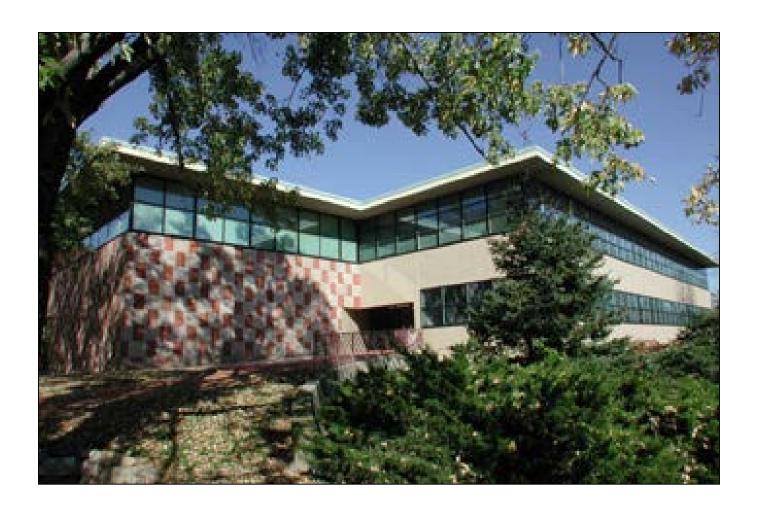
Venturi Gallery-Oberlin College

Moisture damage to signature masonry cladding

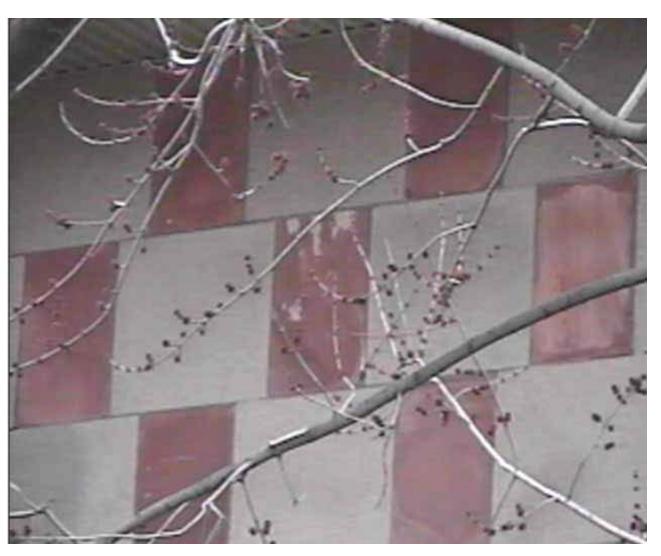
Air and vapor permeable insulation

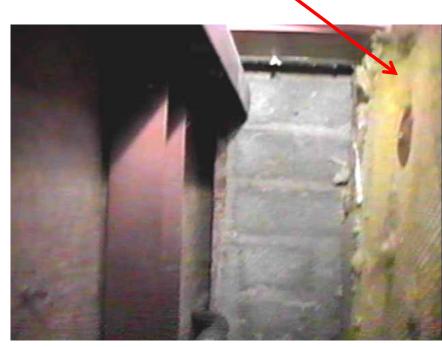
Cavity open to HVAC system

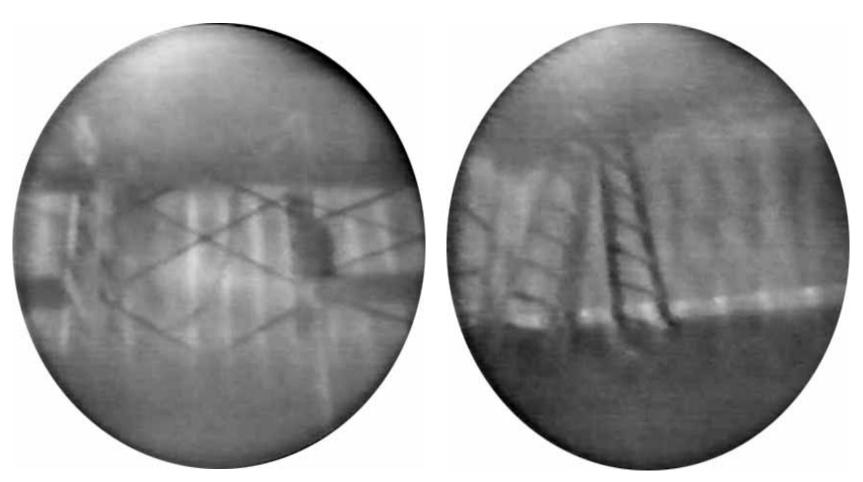
Infrared QA

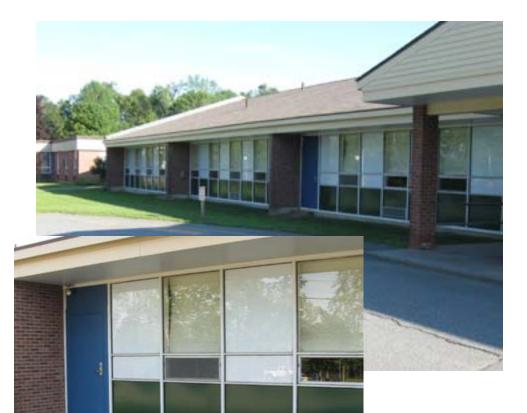
IPF insulation covers 75% of the curtain-wall as part of energy upgrade for local elementary school (Photos taken in 2013, work completed in 1982 – Fill cavity behind the white UV membrane and green spandrel panel areas)

Photos taken in 2013, thirtythree years after the installation

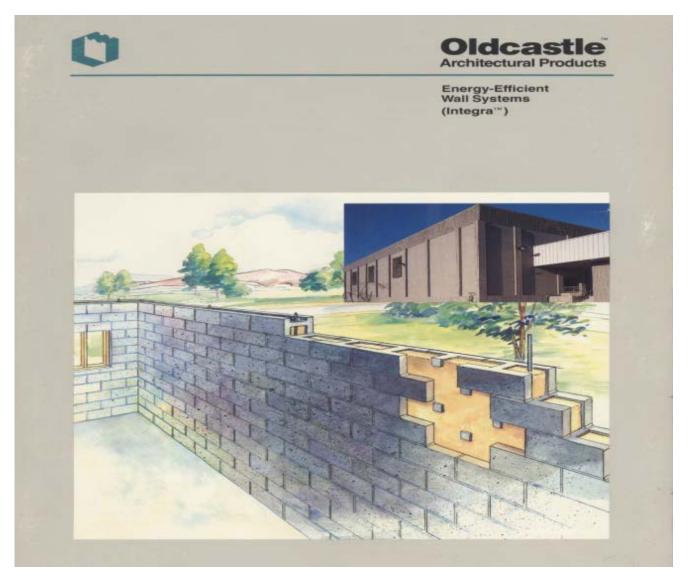
The Integra Wall System has minimal thermal bridging
